**Hewlett Packard
Enterprise**

HPE ProLiant Gen9 Troubleshooting Guide

Volume II: Error Messages

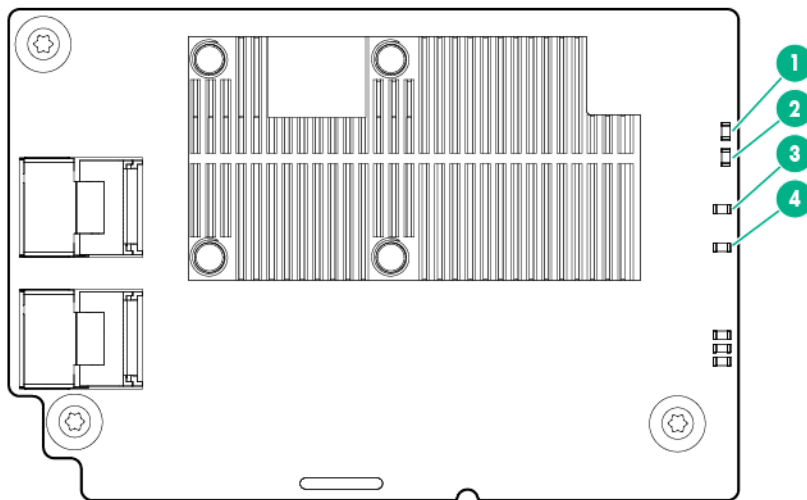
P440ar controller LEDs

Immediately after you power up the server, the controller runtime LEDs illuminate briefly in a predetermined pattern as part of the POST sequence. At all other times during server operation, the illumination pattern of the runtime LEDs indicates the status of the controller.

Item	Color	Name	Interpretation
1	Green	Heartbeat	When the controller is in good health, this LED flashes at 1 Hz. During power-up, this LED is solid for up to 2 seconds.
2	Amber	Fault	When an error occurs, this LED is on. During power-up, this LED is solid for up to 2 seconds.
3	Green	Crypto	On = All attached volumes are encrypted. Off = All attached volumes are plaintext. Flashing = Both encrypted and plaintext volumes are present.
4	Amber	Debug	On = Controller is in reset state. Off = Controller is in an idle or runtime state. Flashing 5 Hz = Controller and cache are performing a backup.

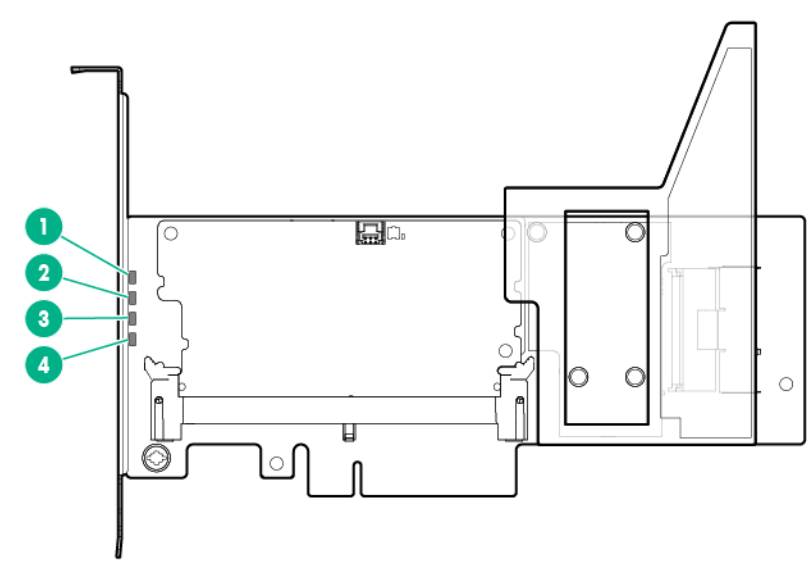
P440 controller LEDs

Immediately after you power up the server, the controller runtime LEDs illuminate briefly in a predetermined pattern as part of the POST sequence. At all other times during server operation, the illumination pattern of the runtime LEDs indicates the status of the controller.

Item	Color	Name	Interpretation
1	Green	Heartbeat	When the controller is in good health, this LED flashes at 1 Hz. During power-up, this LED is solid for up to 2 seconds.
2	Amber	Fault	When an error occurs, this LED is on. During power-up, this LED is solid for up to 2 seconds.
3	Green	Crypto	On = All attached volumes are encrypted. Off = All attached volumes are plaintext. Flashing = Both encrypted and plaintext volumes are present.

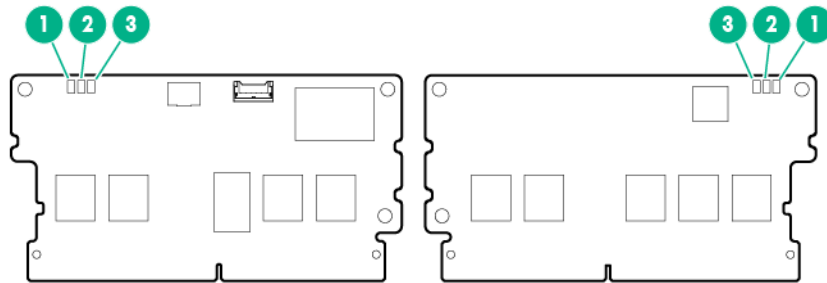
Cache module LEDs (For standup Smart Array controllers)

The cache module has three single-color LEDs (one amber and two green). The LEDs are duplicated on the reverse side of the cache module to facilitate status viewing.

1 - Amber	2 - Green	3 - Green	Interpretation
Off	Off	Off	The cache module is not powered.
Off	Flashing once every 2 seconds	Flashing once every 2 seconds	The cache microcontroller is executing from within its boot loader and receiving new flash code from the host controller.
Off	Flashing once per second	Flashing once per second	The cache module is powering up, and the battery is charging.
Off	Off	Flashing once per second	The cache module is idle, and the battery is charging.
Off	Off	On	The cache module is idle, and the battery is charged.
Off	On	On	The cache module is idle, the battery is charged, and the cache contains data that has not yet been written to the drives.
Off	Flashing once per second	Off	A backup of the DDR content on the cache module is in progress.
Off	On	Off	The current backup is complete with no errors.
Flashing once per second	Flashing once per second	Off	The current backup failed, and data has been lost.

Flashing once per second	Flashing once per second	On	A power error occurred during the previous or current boot. Data may be corrupt.
Flashing once per second	On	Off	An overtemperature condition exists.
Flashing twice per second	Flashing twice per second	Off	The battery is not connected to the system board.
Flashing twice per second	Flashing twice per second	On	The battery has been charging for 10 minutes, but has not reached sufficient charge to perform a full backup.

1 - Amber	2 - Green	3 - Green	Interpretation
On	On	Off	The current backup is complete, but power fluctuations occurred during the backup.
On	On	On	The cache module microcontroller has failed.
